PSICRE14

2014 and newer Chevrolet® Silverado & GMC® Sierra Crew-Cab 1500 series with base radio

2015 and newer Chevrolet® Silverado & GMC® Sierra Crew-Cab 2500/3500 with base radio

Subwoofer Assembly

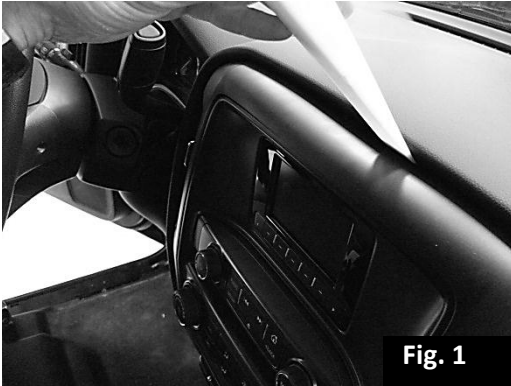
1. Disconnect negative battery cable from battery. (For diesel engines with dual batteries disconnect both negative cables)
2. Pry loose the radio bezel. Fig. 1
3. Remove the four screws securing the radio and HVAC controls. HVAC control wiring does not need to be disconnected. Fig. 2

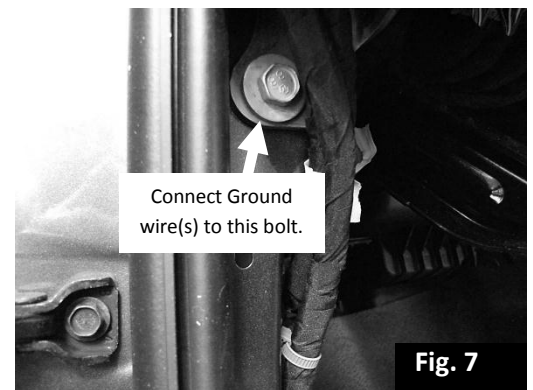
15. Connect the black ground wire of both the amplifier and subwoofer harness to the bolt next to the park brake pedal indicated in Fig 7 Torque to 9 +/- 1.5 Nm

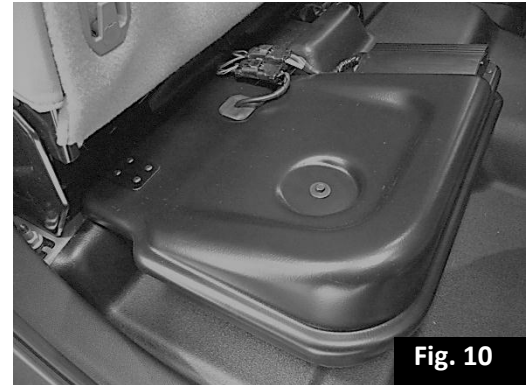
21. Connect the subwoofer wiring to the subwoofer harness and set the enclosure into place by sliding the center bracket through the slit in the carpet and over the seat stud and seatbelt receptacle stud. Fig. 10
22. Reinstall the rear center seatbelt receptacle over the top of the subwoofer bracket and reinstall the factory nut. Torque to 53 Nm (39 ft/lb)
23. Reinstall the rear seat nut and torque to 109 Nm (80 ft/lb)
