# SCOCRE15

Designed for 2015 and newer Chevrolet® Colorado and GMC® Canyon Crew Cab vehicles

#### **Power Harness Routing**

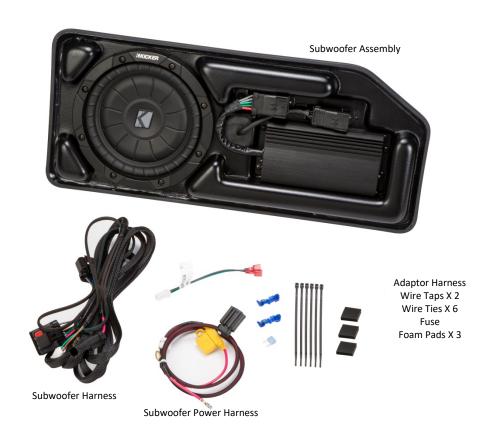
- 1. Disconnect negative battery cable.
- 2. Make sure supplied fuse is not installed in fuse holder and connect the subwoofer power wire to the stud pictured in figure 1. Tighten to 4.7Nm (42in-lb)
- 3. Route the power harness toward the firewall and secure with supplied wire ties.
- 4. Make a small incision in the grommet on the driver side of the firewall and pass the power harness into the cabin. Fig. 2
