PFSDC12

Designed for 2012 and newer Ford® F250/F350 Super Crew

#### **Power Harness Routing**

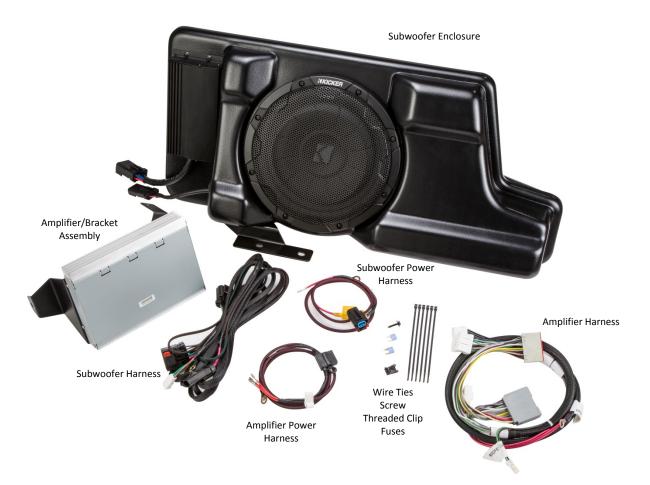
- 1. Disconnect negative battery cable.
- 2. Make sure supplied fuses are not installed in fuse holders and connect the subwoofer power wire and the amplifier power wire to the stud pictured in Figure 1.
