PF150C09

Designed for 2009–2010 Ford® F-150 Super-Crew vehicles

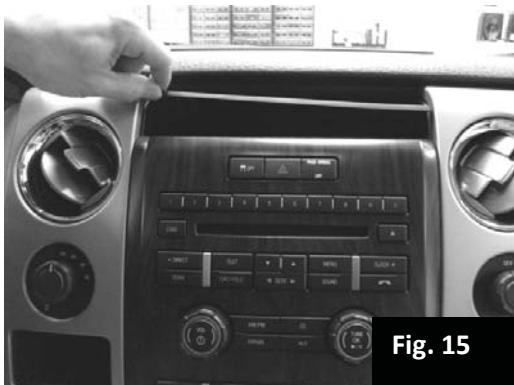
24. Pull loose the rubber tray above the radio and remove the two screws beneath it. Fig. 15
25. Remove the two screws in the top of the instrument cluster bezel. Fig. 16

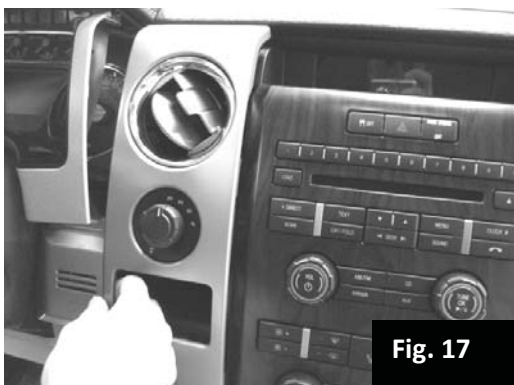
26. Pull the bezel loose, but do not completely remove. The bezel just needs to be loose enough to allow the left vent assembly to be removed.
27. Pull loose the left vent assembly and remove. Fig. 17
28. Open the glove compartment and squeeze the sides to allow it to fold all the way down.
29. Find the three bolts securing the passenger side airbag assembly and remove it. Fig. 18
