## PMUSP12

*Designed for 2012 Ford® Mustang vehicles*

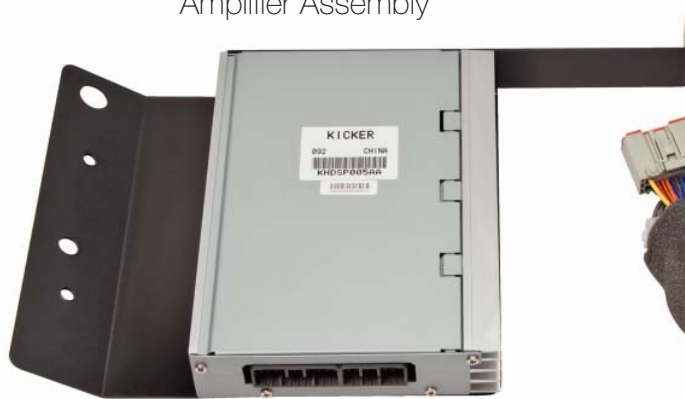
Amplifier Assembly

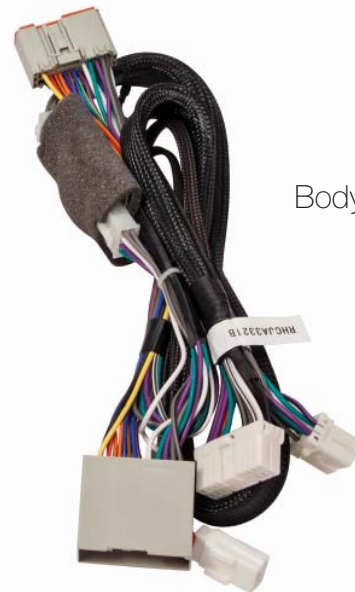
Body Harness

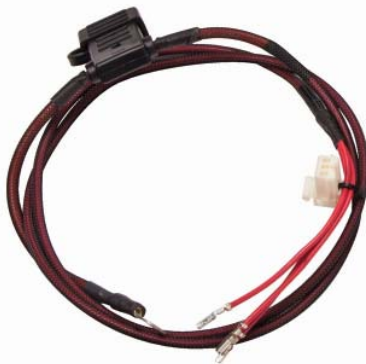
Power Harness

25A Fuse  
Wire Ties x6  
Star Washer

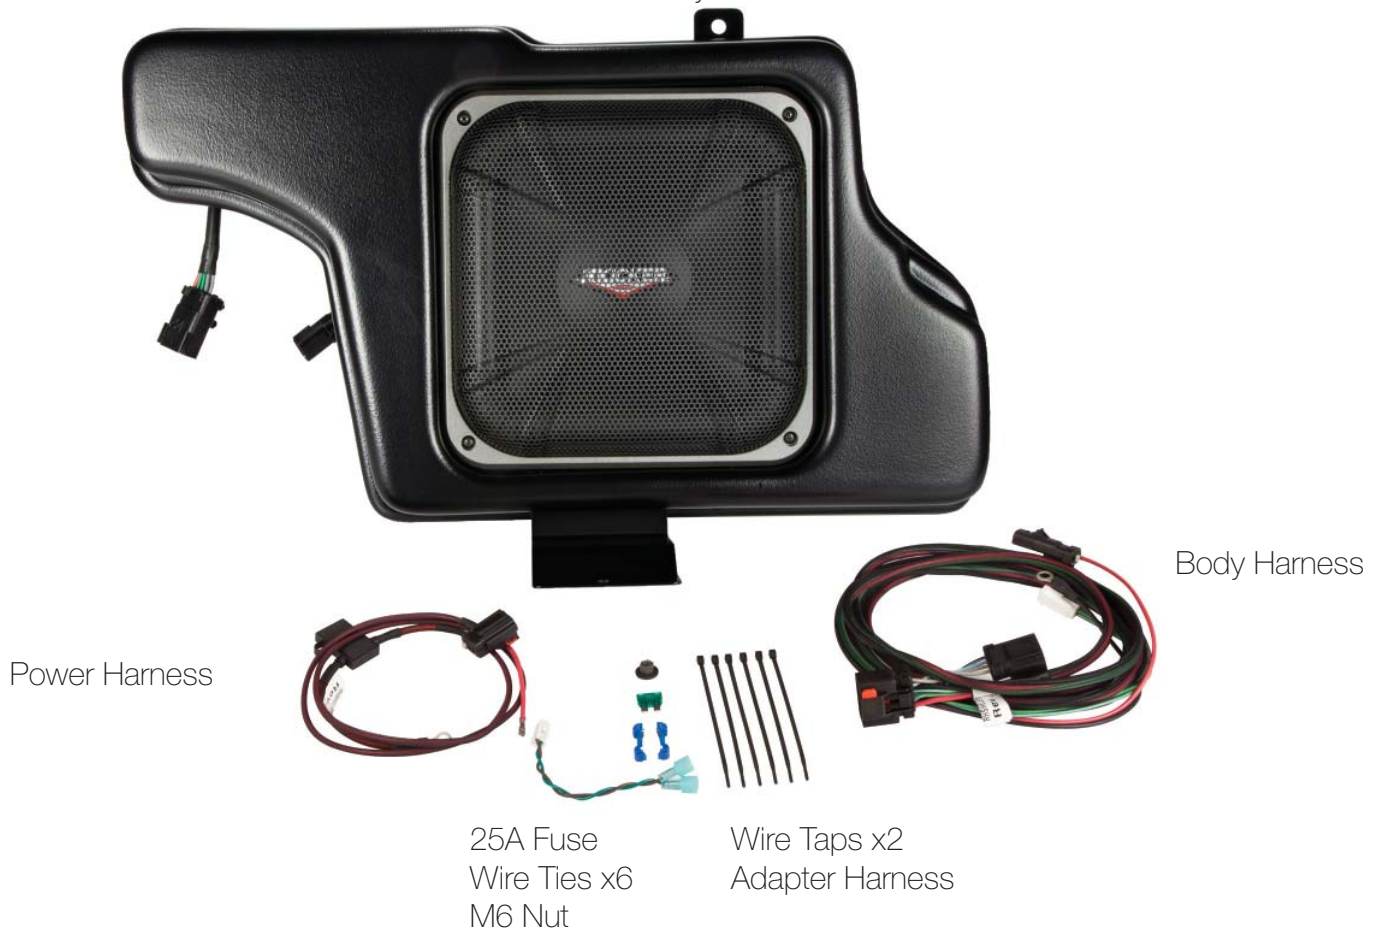
## Subwoofer Assembly

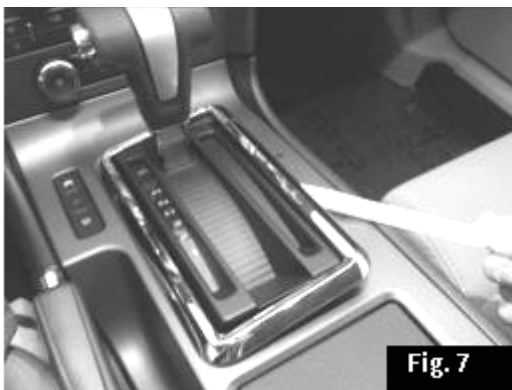
11. Using a panel removal tool gently pry loose the bezel around the shifter and remove. Fig. 7

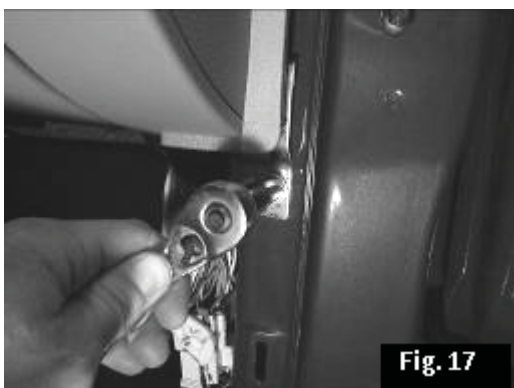
24. Connect the black ground wire of the amplifier harness and the subwoofer harness to the bolt in just below the edge of the dash. Torque to 20Nm. Fig. 17

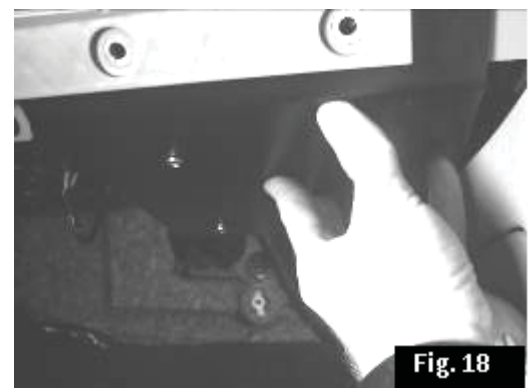
25. Install the amplifier/bracket assembly over the HVAC blower housing stud and behind the bottom of the glove compartment. Line up the holes in the bracket with the holes in the glove compartment and reinstall the screws, leave loose. Fig. 18

26. Reinstall the nut and provided star washer on the blower housing stud and tighten, then tighten the glove compartment screws.

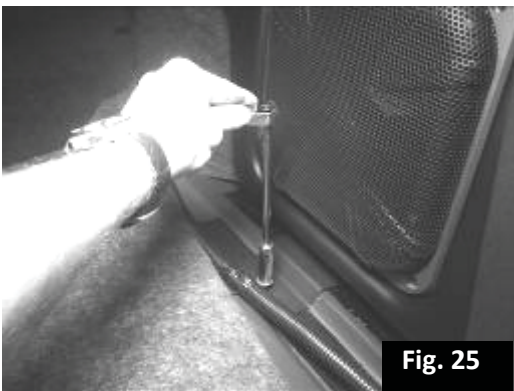
41. Push the subwoofer toward the outside of the car as far as possible and install the supplied 10mm nut on the factory stud and tighten. Fig. 25

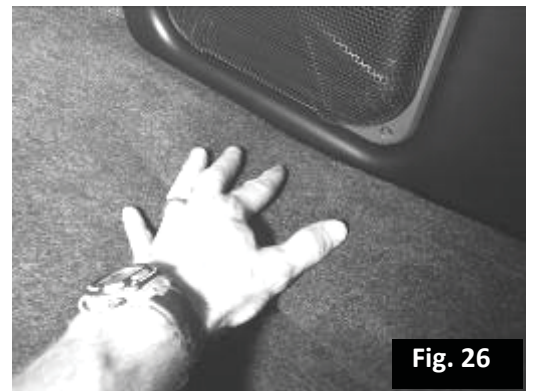
42. Fold about six inches of the trunk liner underneath itself and then tuck the fold under the edge of the subwoofer. Fig. 26
