PMUSP14

Designed for 2014 Ford® Mustang vehicles with premium Shaker™ audio.

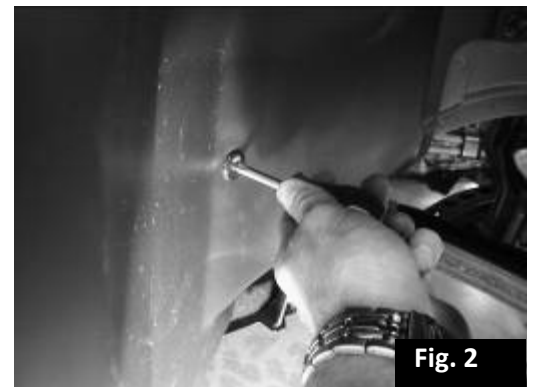
1. Disconnect negative battery cable.
2. Turn the steering wheel as far as possible to the left.
3. Using a straight screwdriver pry out the center portion of the two plastic retainers that secure the rear portion of passenger's side front fender well. Once the center portion is pried out, remove the outer portion. Fig. 1
4. Using a Phillips screwdriver unscrew the centers of the other four plastic retainers securing the rear half of the fender well and then pull out the outer portion. Remove the fender well. Fig. 2

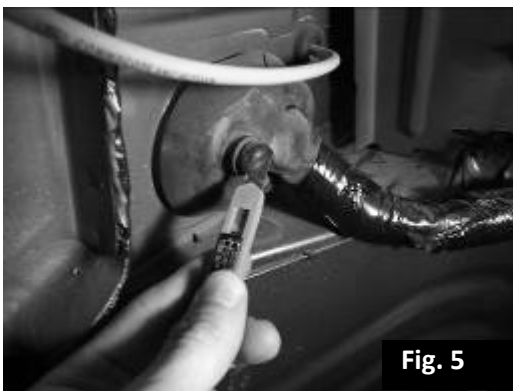
8. Using a razor knife make a small incision in the rubber grommet. Fig. 5
9. Pass the power harnesses into the cabin and secure with the provided wire ties. Fig. 6
10. From the inside of the car, install the provided white three pin connector on the end of the amplifier power harness. (Any wire can be installed in any position.) Install the two pin black connector on the subwoofer power harness.

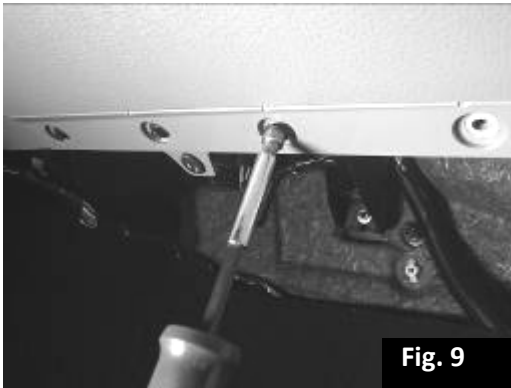
14. Remove the four screws along the bottom of the glove compartment. Fig. 9

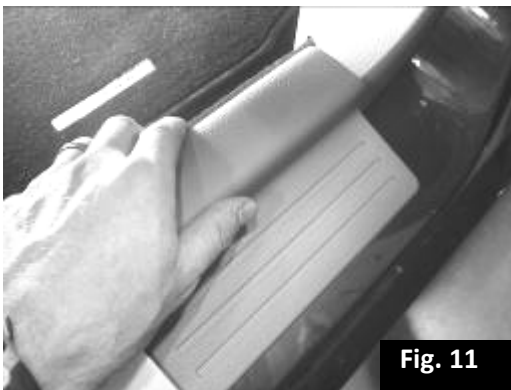
16. Remove the sill plate along the bottom of the passenger's side door opening. Fig. 11

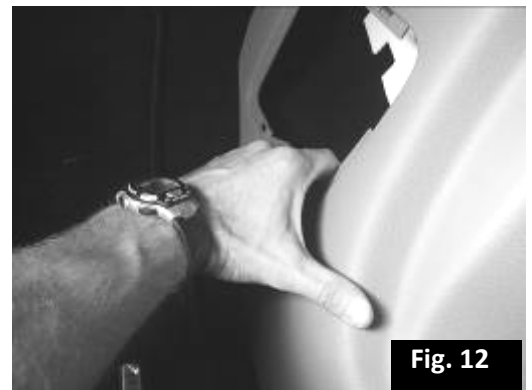
17. Remove the passenger's side kick panel by pulling toward the center of the car and then straight back to release the fasteners. Fig. 12

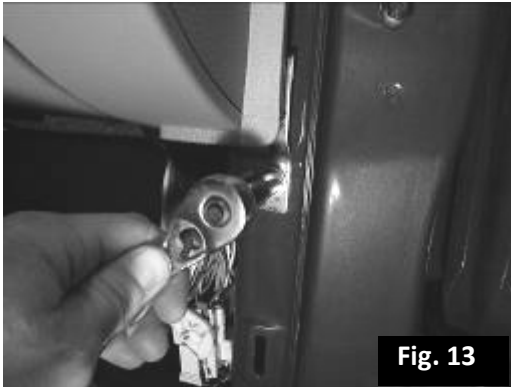
19. Connect the black ground wire of the amplifier harness and the subwoofer harness to the bolt just below the edge of the dash. Torque to 20Nm. Fig. 13
20. Install the amplifier/bracket assembly over the HVAC blower housing stud and behind the bottom of the glove compartment. Line up the holes in the bracket with the holes in the glove compartment and reinstall the screws, leave loose. Fig. 14

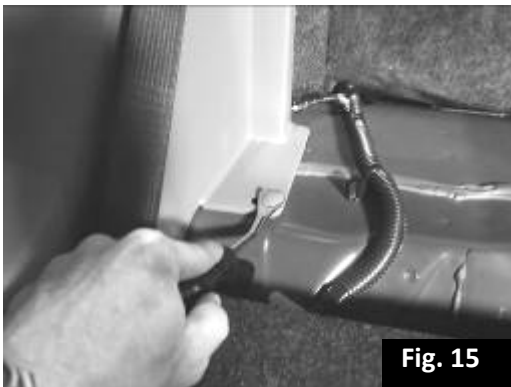
21. Reinstall the nut and provided star washer on the blower housing stud and tighten, then tighten the glove compartment screws.
22. Connect the amplifier power harness white three pin connector to the corresponding white three pin connector of the amplifier body harness. Connect the subwoofer power harness black two pin connector to the corresponding black two-pin connector of the subwoofer body harnesses.
23. Remove the lower rear seat cushion by pushing the front edge back and then lifting up.
24. Release and fold down the rear seat backs.
Remove the three plastic retainers that secure the quarter panel cover. One retainer is above the floor pan and the other two are located in the pass through area between the cabin and the trunk. Fig. 15
25. Pull the rear quarter panel cover and remove from the car. Fig. 16

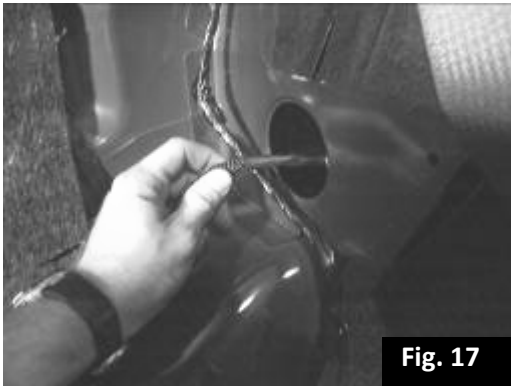
28. Pass the subwoofer body harness through the round hole in the metal. Fig. 17

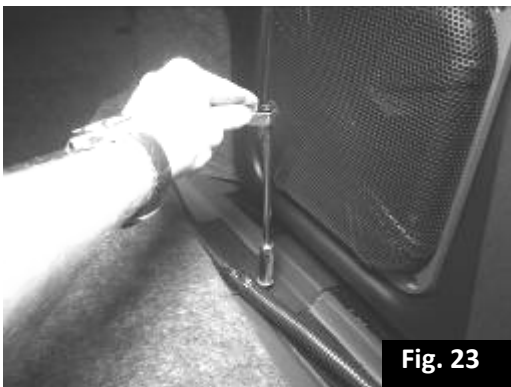
Fig. 23

35. Push the subwoofer toward the outside of the car as far as possible and install the supplied 10mm nut on the factory stud and tighten. Fig. 21

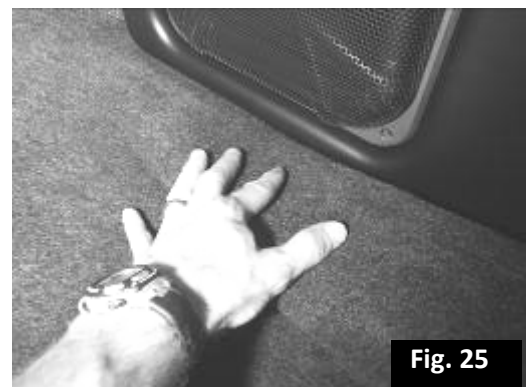
Fig. 25

36. Fold about six inches of the trunk liner underneath itself and then tuck the fold under the edge of the subwoofer. Fig. 22
